54-4-1 AC Spark Plug Applies to All Engines Equipped With AC LA-87 Spark Plugs, Except Pratt and Whitney R-1830 Engines of 1,200 HP or Less and Wright R-1820 Engines of 1,200 HP or Less.

50-18-3 Air Associates Applies to Model M-264 Safety Belts Incorporating Warren McArthur End Fittings, P/N 275-AS26 (Air Associates P/N M-1842).

50-4-1 Briggs and Stratton Applies to All Aircraft Equipped With Army Air Force Type A-8 Ignition Switches Manufactured by Briggs and Stratton.

57-14-2 Davis Aircraft Products (Safety Belts) Applies to Model FDC-1650 Belts, (P/N FDC-1650, FDC-1650-27, FDC-1650-27M1).

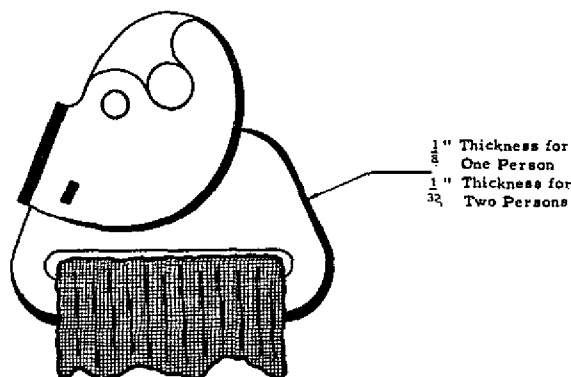
FIGURE 1

Warren McArthur end fittings, P/N 275-AS26 (Air Associates P/N M-1842) have been

WARREN MCARTHUR FITTING NO. 275-AS26

found to be of insufficient strength for use in two-person belts. These fittings are not marked, have a fitting plate thickness of $\frac{1}{8}$ inch, and may be identified by comparison with Figure 1. One-person belts using these fittings must be modified not later than the next annual inspection (or the next seat overhaul for aircraft on a continued maintenance basis) so that the label will read "APPROVED FOR ONE PERSON". This may be done by blanking out the words "OR TWO" and the letter "S" in the word "PERSONS" on the label with India ink or an equally effective method. All such belts presently used in two-person applications shall be removed and replaced by other belts approved for two persons not later than May 1, 1950.

Care should be taken not to confuse these fittings with another Warren McArthur fitting P/N 13971 (also known as P/N 314-AS12) which is identical in appearance except that the fitting plate thickness is $\frac{5}{32}$ inch.

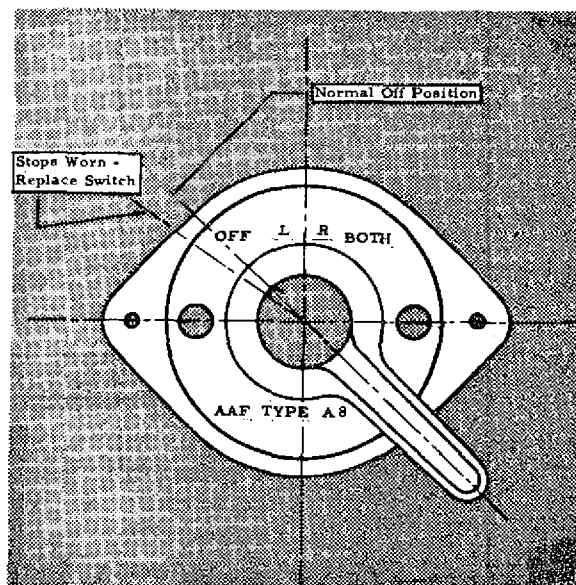
FIGURE 1

A serious hazard may exist on this type switch after considerable use has worn the internal switch lever stops, allowing overtravel past the "Off" position. Such overtravel may allow the magneto ground to be broken and permit the engine to fire when the switch is in the "Off" position.

1. Inspection should consist of the following: Check switch lever for overtravel past the "Off" position. Figure 1 shows the location of the switch lever in the "Off" position. The pointer projecting from the lever points to the middle "F" in the word "Off". When the lever can be turned to a point beyond the cen-

terline of the "O" in the word "Off", the rotation stops have become worn and the switch should be replaced.

2. This inspection must be repeated at 100-hour intervals.

3. Inspection may be discontinued if switch is replaced by Type A-8 of another make or by some other satisfactory type ignition switch.

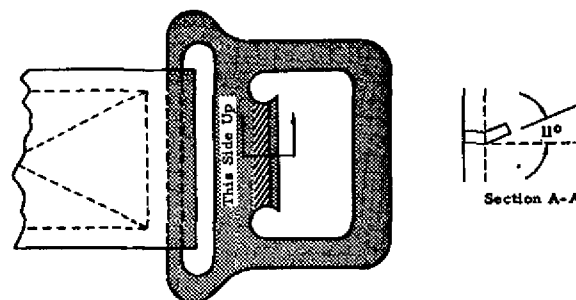
FIGURE 1

Some of the release fittings of the subject belt assemblies are so constructed as to require one particular side of the fitting UP when being inserted in the buckle.

It is possible to improperly fasten the belts effected so that the buckle may become unfastened under load. The unsatisfactory release fittings have a tab bent up to an angle of approximately 11° with the plane of the fitting (see Figure 1).

To provide for securely assembling the buckle with the release fitting in either position, the tab area indicated in the sketch must

be removed or bent flush with the plane of the adjoining metal.

This rework applies only to the release fitting shown in the sketch. Other portions of the buckle assembly than that shown should not be modified. This condition has been corrected on all assemblies of current manufacture.
